Bethal Sewerage Treatment Works – Case Study 2003

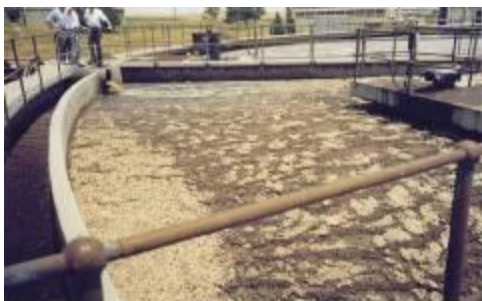
The sludge in the primary chamber became too thick and burnt out the stirrer motor, resulting in the system not functioning correctly. The final effluent being discharged into the river contaminated the water and many livestock had died. The effluent contained a high volume of fats from the dairy and chocolate factory.

A. Congested primary chamber

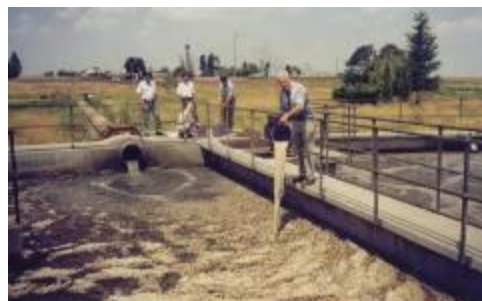
B. Dosing the primary chamber

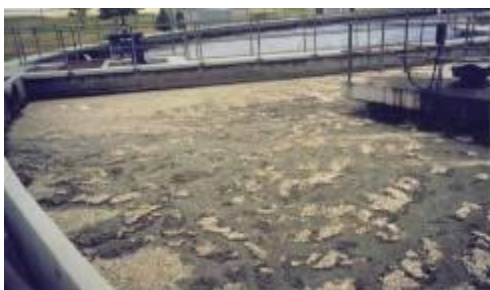
C. 3 days after dosing commenced

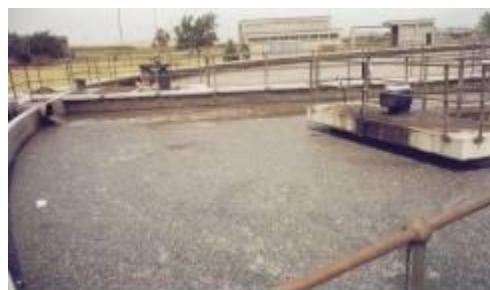
D. 2 weeks into dosing and the main solids have liquefied

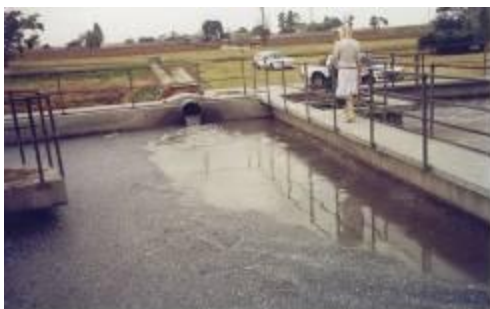
E. Effluent liquid, just fat balls still floating on the surface

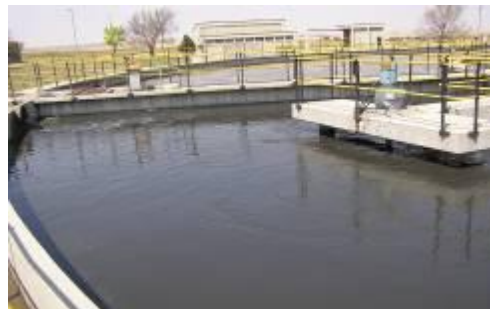
F. New stirrer installed once the effluent was thin enough
